Research And
Evaluations In
Architecture, Planning
AND DESIGN

**Research And
Evaluations In
Architecture, Planning
And Design**

SEISMIC ENHANCEMENT THROUGH REPAIR AND RETROFITTING FOR MASONRY STRUCTURES DAMAGED BY THE 2023 KAHRAMANMARAŞ EARTHQUAKES

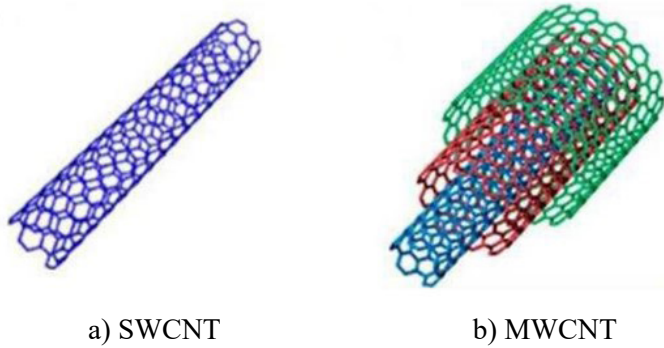
Figure 3. Representation of SWCNT and MWCNT (Pitroda & Jethwa, 2016)

Carbon nanotubes; It has a cylindrical shape between approximately 1 and 50 nanometers and is classified as single (SWCNT) or multilayer (MWCNT) (Figure 3). Their lengths can vary from a few micrometers to 550 micrometers and their diameters can vary up to 550 micrometers. It has been observed that the mechanical properties of concrete are significantly improved by adding small amounts of carbon nanotubes to cement (Wang et al., 2009).

The compressive strength and bending strength of concrete have increased with multilayer nanotubes. Compared with traditional samples, it provided an advantage of +8 N/mm² in bending strength and +25 N/mm² in compressive strength (Alsafar, 2014).

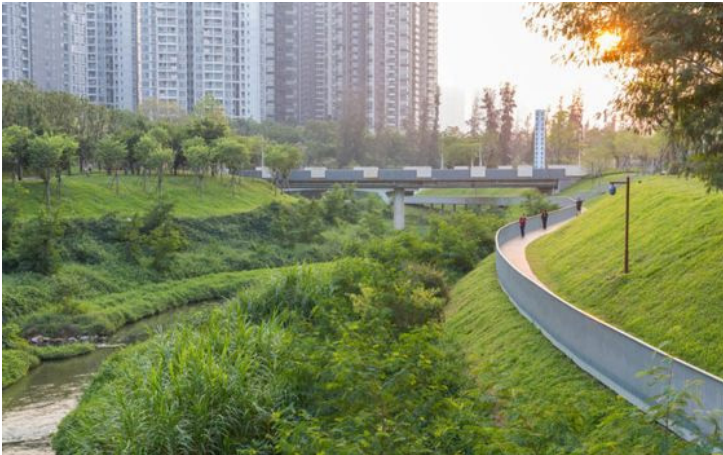
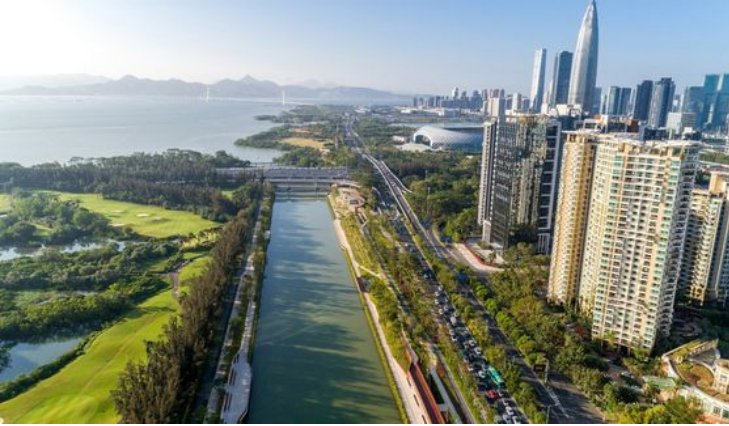
Ecological corridors and connections of cities are the integrating elements of rural and urban green tissue. By considering corridors and connections as a whole, a healthy ecological integrity that complements each other will be realised. One of the most important elements of urban corridors is 'urban roads' (Çetinkaya, 2013). One of the most important elements of urban corridors is undoubtedly urban roads. Urban road networks are indispensable facilities of cities and should be carefully considered in terms of their corridor potentials and the aesthetic, ecological and economic values they add to the city in this sense. Urban road networks also determine the quality of the corridors they form. In this sense, applications that enrich urban corridors in terms of function and aesthetics gain importance. Urban road networks supported with vegetative materials assume the roles of binding and complementing between open and green areas such as squares and parks, which are the elements of another urban corridor, and thus the green texture spreads to the city through corridors (Figure 2)(Yerli & Kesim, 2009).

Figure 2. Dasha River Ecological Corridor-Shenzhen, China(Url-3; Url-4)

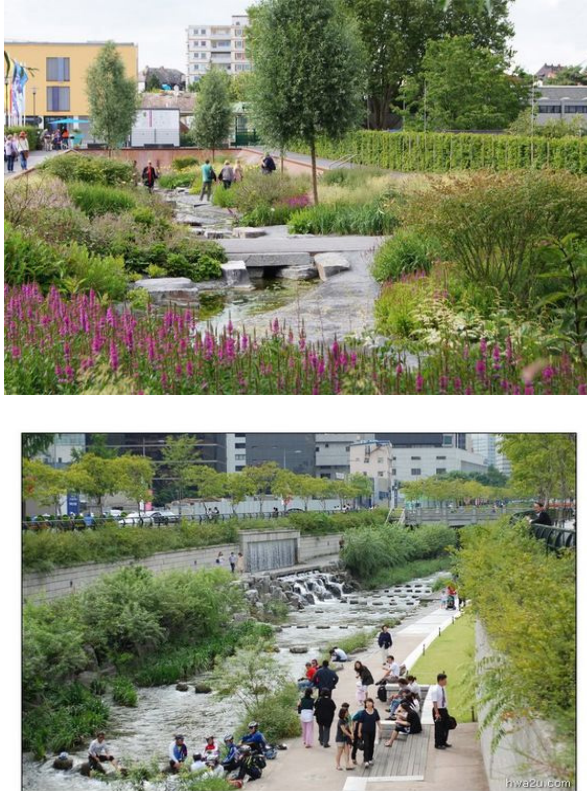
There are three main components that should be present in an urban ecological network system (Figure 5). These are core zones or repair zones, corridors/connections and buffer zones. Core zones are inner zones that protect important habitats, species and ecosystems. Corridors and linkages are the lines that connect core areas with belts and corridors that provide communication and communication opportunities. They undertake the task of providing habitat for fauna and flora species in landscapes where people are densely populated (such as urban environments) (Bennet, 2003).

Figure 5. Urban Ecological Network System(Url-8;Url-9)

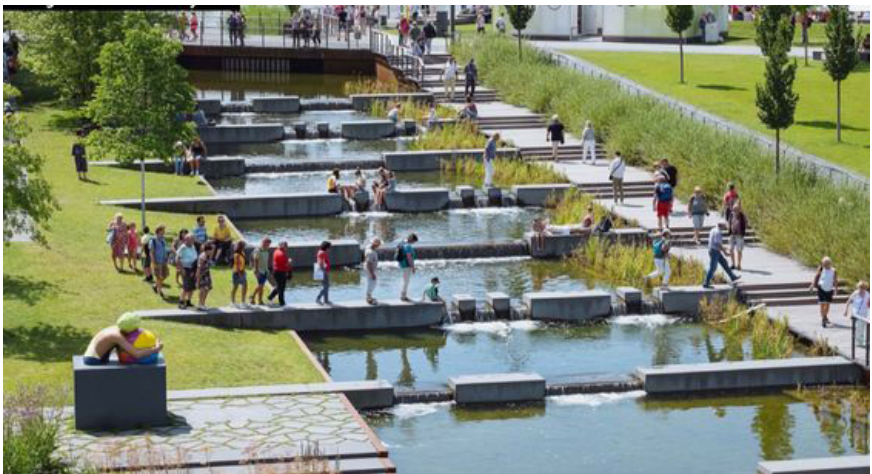
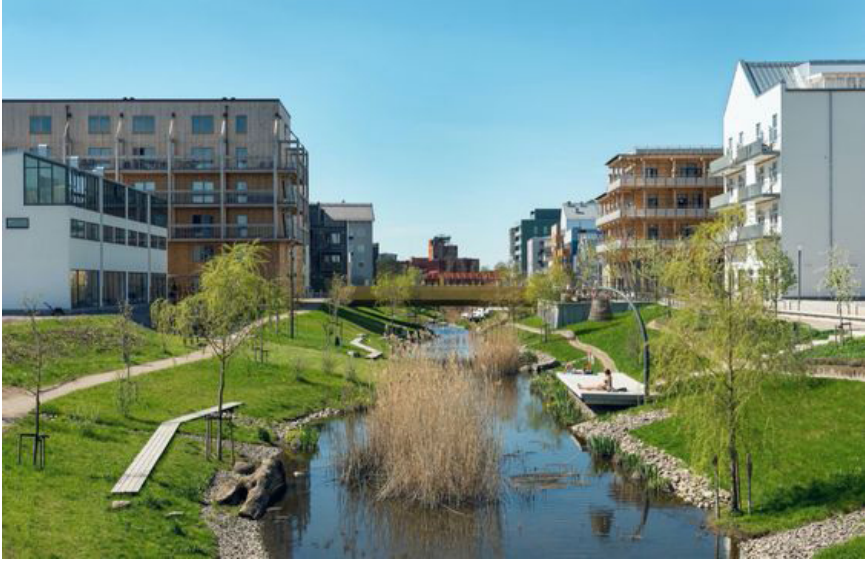
Figure 6. Urban Green Infrastructure Systems (Url- 10;Url-11)

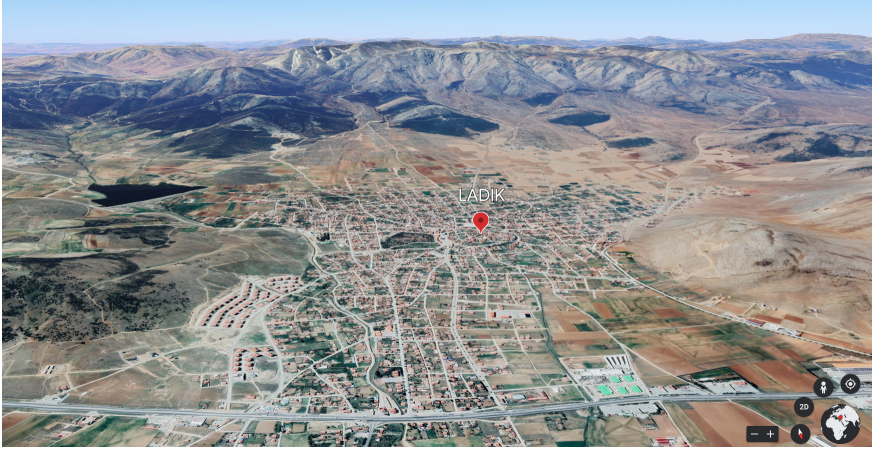
There are small mountains to the east and west of this ancient settlement established at the foot of Laodicea Mountain, which is considered a continuation of the Taurus mountains (Erdemir, 2014). The south is surrounded by mountain ranges, and the north is a plain (Figure 3). Its height from the sea is about 1160 meters. It is located at an altitude of about 100 meters from the district center of Sarayönü. A typical continental climate is observed. Due to the fact that the neighborhood is open to the north wind, the winter months are quite harsh. The settlement is spread over a circular area with a radius of 4 kilometers. The only elevation of the settlement, the terrain of which is quite flat, is Ladik Höyük, located in the center.

Figure 3. *3D view of Ladik (URL-3)*

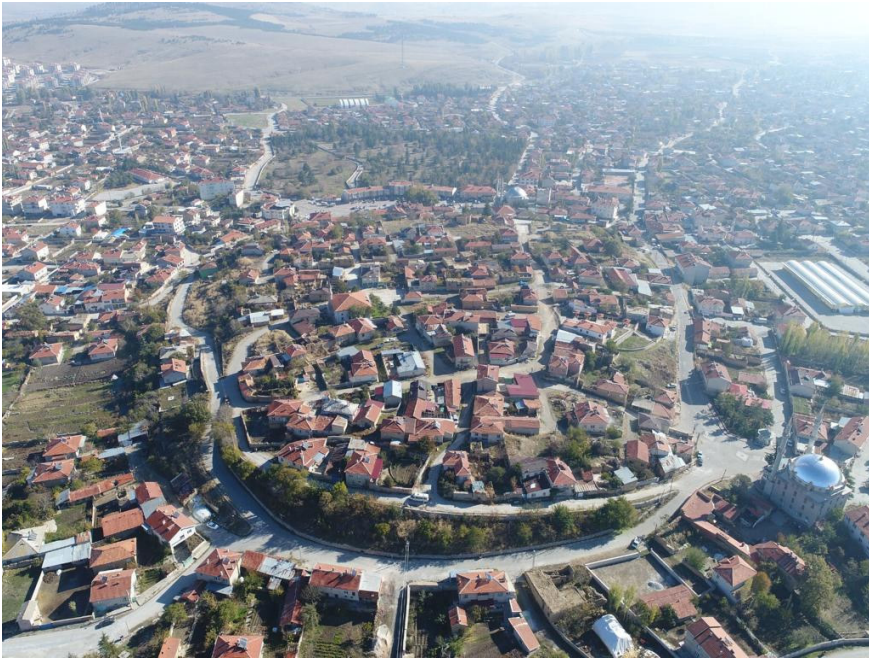
Figure 5. *General view of Lâdik Höyük*

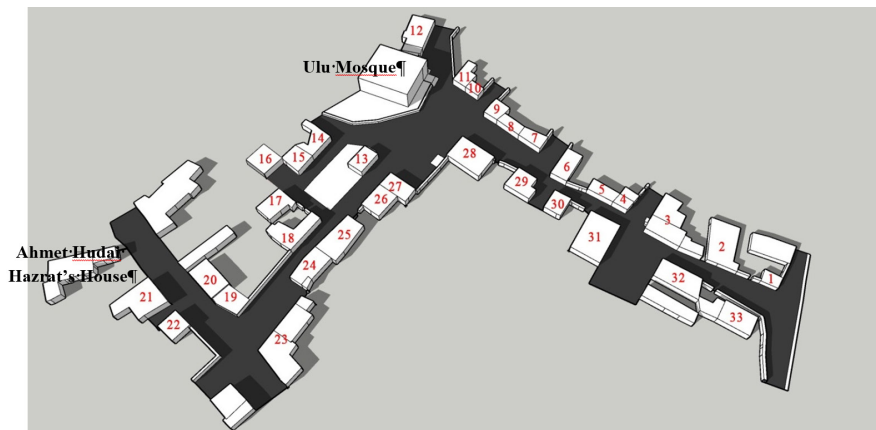
There are 41 buildings in the area where the study was conducted. The general appearance of the study area and the locations of the structures within it are shown as follows (Figure 7).

Figure 7. General view of the structures located in the study area

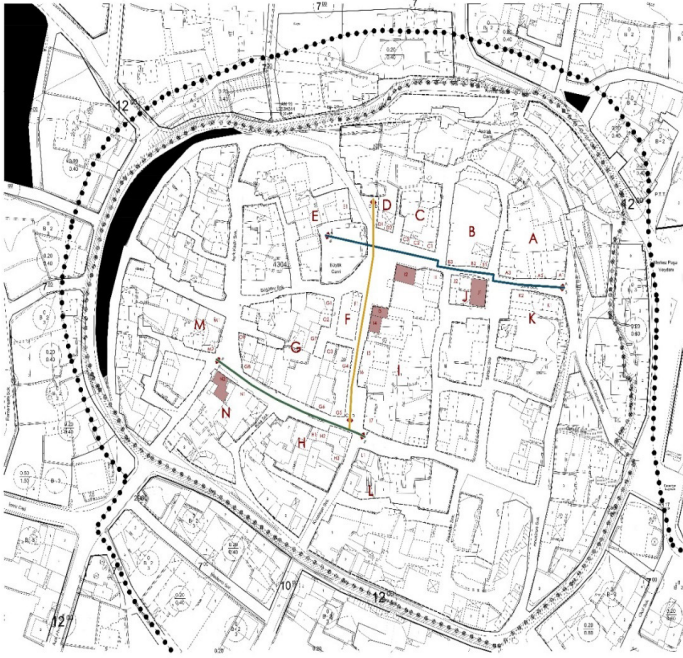
The construction material of 36 of the total 41 structures located in the project area is adobe, and only 5 of them are reinforced concrete. The reinforced concrete structures are the structures in the parcels numbered 1475, 1476, 1480, 1483 and 1434 located on the island numbered 1177 (Figure 8).

Figure 8. *The positions of the reinforced concrete structures in the area where the study was carried out*

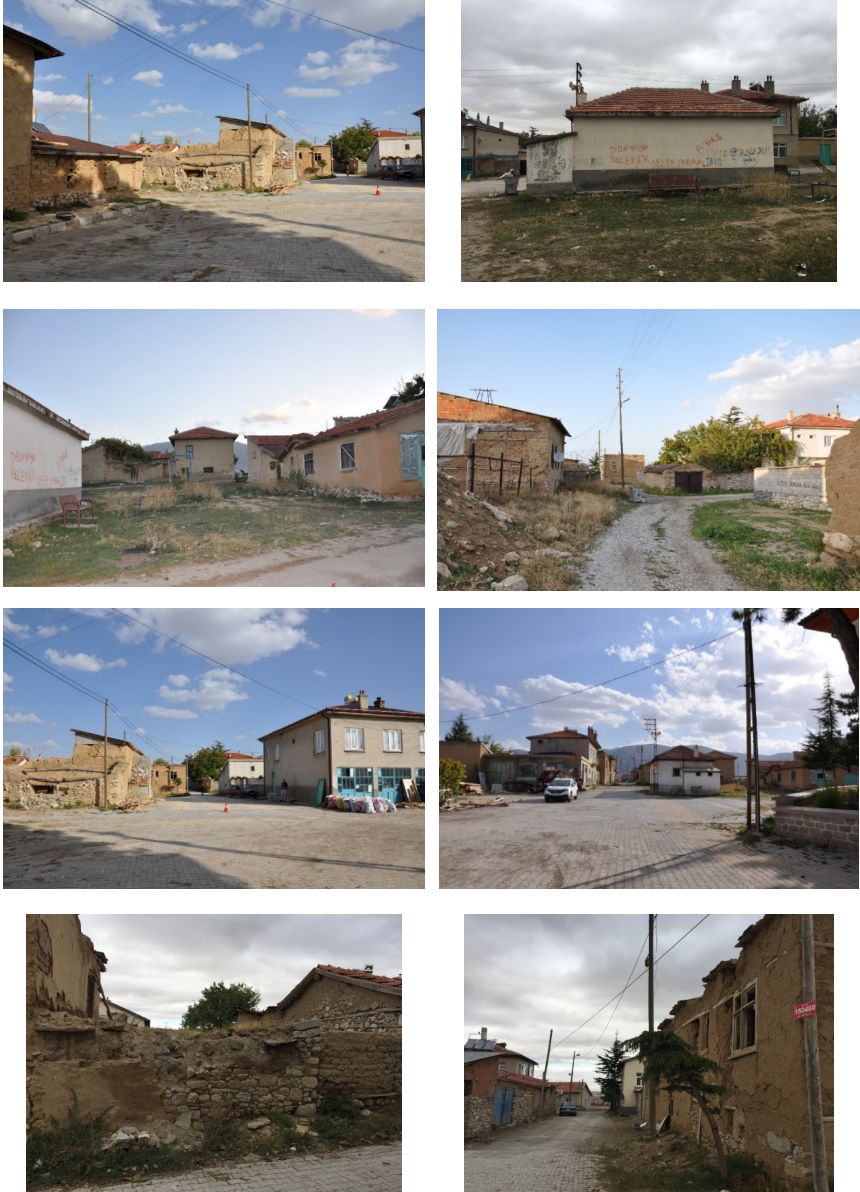
Table 1. *General view of the structures and urban spaces located within the study area*

When we look at the general condition of the structures located on the streets subject to the project, it is seen that many of them are quite decrepit, in a state of disrepair and add an unhealthy appearance to the overall texture of the streets. Urban spaces and open spaces, except for the structures located along the streets, give the street undefined and unhealthy views in the same way. It offers a very unhealthy appearance with electricity poles, wire cables, walls that are about to collapse, outdated building facades, neglected roofs and chimneys, rather outdated living units that can be seen in places in open areas, children's playgrounds and green texture that are not qualified along the streets (Table 1). However, in addition to being located in a very important position from an identity point of view, this area also includes the house of Ahmet Hudai of Ladik, which is one of the important triangulations and tourist points of Ladik. The solution to the problems of the project area, which is located in such an important

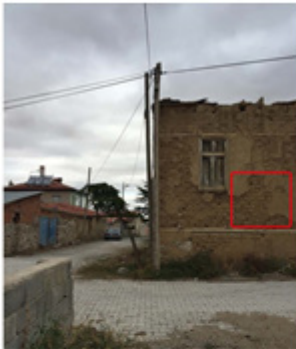
Repair of facades with adobe plaster

- Repair simple facade distortions with adobe plaster and painting the facade white
- Repair of roofs with pantile type tile roof cover
- Renovation of window and door joinery with wooden material
- Renovation of railings with knotted iron grille
- Renovation of rain gutters
- Renovation of roof pediments
- Renovation of chimneys

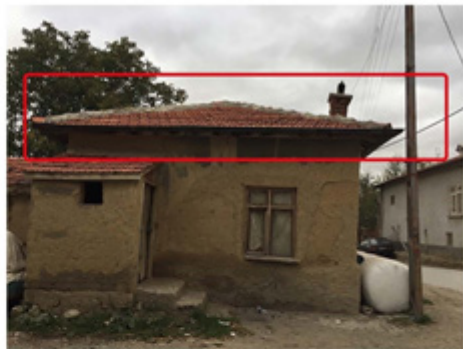
Repair of roofs with pantile type tiles

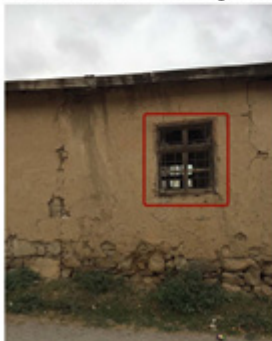
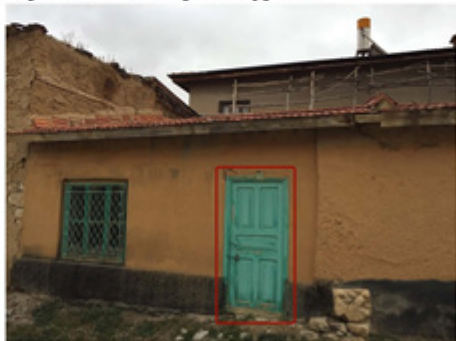
Renovation of window and door joinery with wooden material

Renovation of railings with knotted iron grille

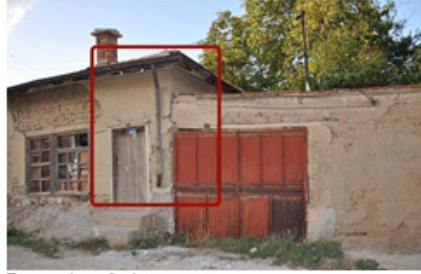
Renovation of rain gutters

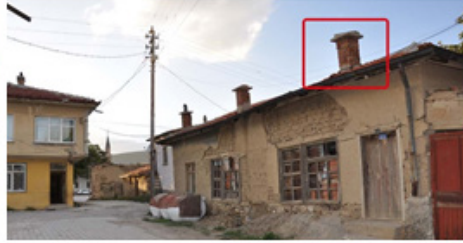
Renovation of chimneys

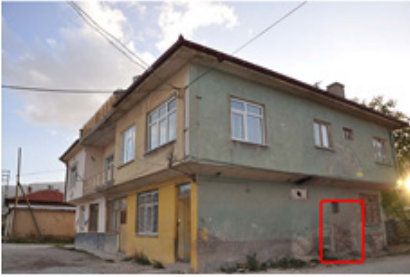
Repair of distortions on facades with plaster

- Repair simple facade distortions with plaster and painting the facade white
- Repair of roofs with marseille type tile roof covering and making the roof constructions of structures without a roof using marseille-type tile roof covering
- Renovation of rain gutters
- Renovation of window joinery with pvc material with wooden appearance
- Renovation of door joinery with wooden-looking aluminum material
- Renovation of chimneys

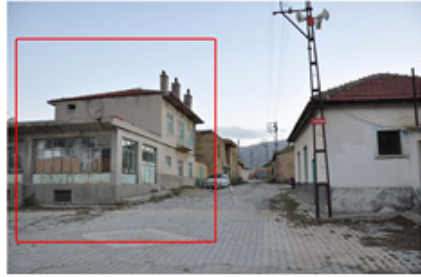
Completion of structures without a roof with marseille-type tiles

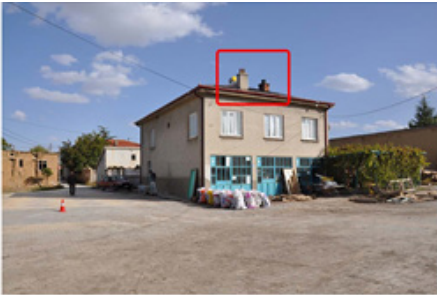
Repair and cleaning of chimneys

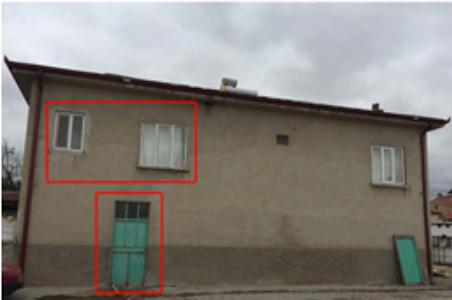
Renovation of window joinery with pvc material with wooden appearance

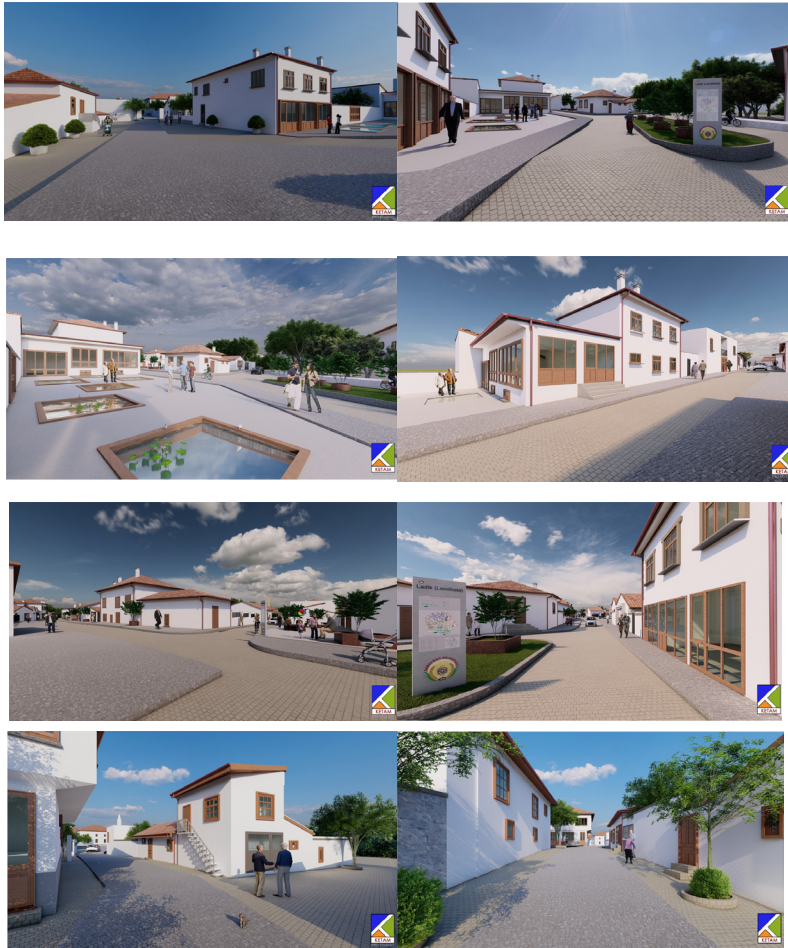
Table 4. Three-dimensional narratives for the field of work

The effect of the simple repairs to be made for the immovables in the work area and the suggestions made for urban accessories in the third dimension have also been tried to be explained by modeling (Table 4).

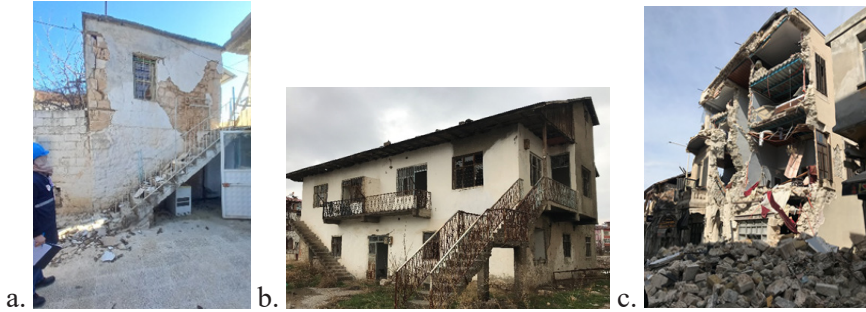
Figure 6. a. A damaged masonry 2-floor village house in Nizip, Gaziantep b. Slightly damaged masonry house in the city center of Elbistan, Kahramanmaraş c. Extensive partial collapse of a masonry 4-floor building in Antakya, Hatay city center.

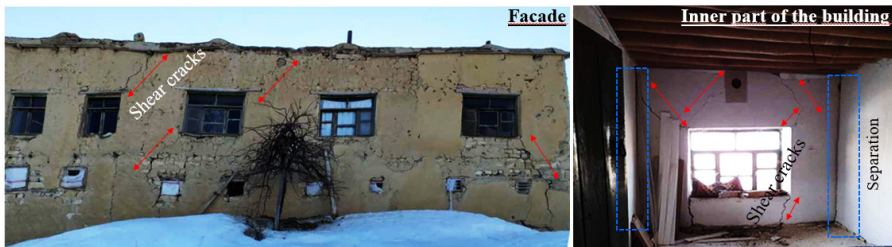
Figure 7. Shear cracks within the plane of masonry walls, coupled with separation.

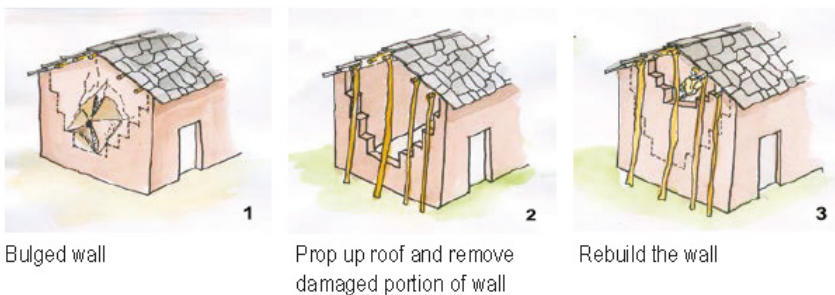
Figure 10. Steps of rebuilding a wall with out-of-plane failure (Government of Nepal National Reconstruction Authority, 2021)

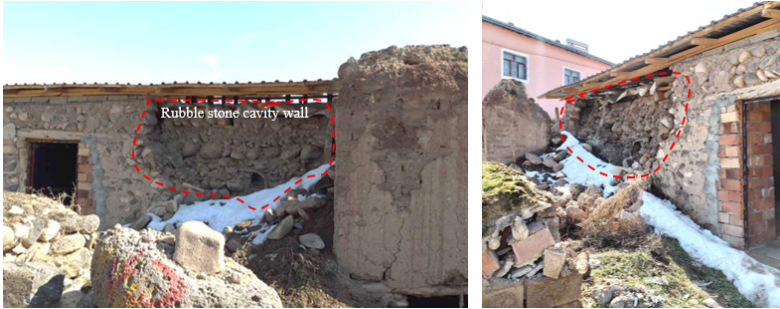
Figure 11. *The outer rubble stone wall delamination in Malatya*

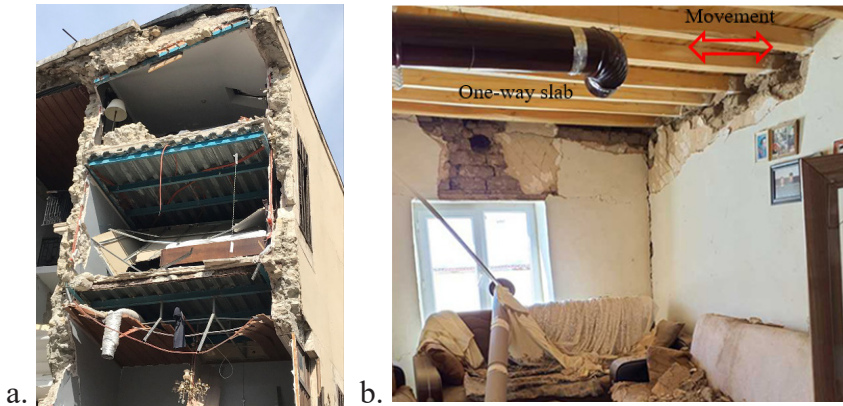
Figure 13. a. *Slab-to-wall connection failure* b. *Inappropriate anchorage of timber joist in adobe masonry*

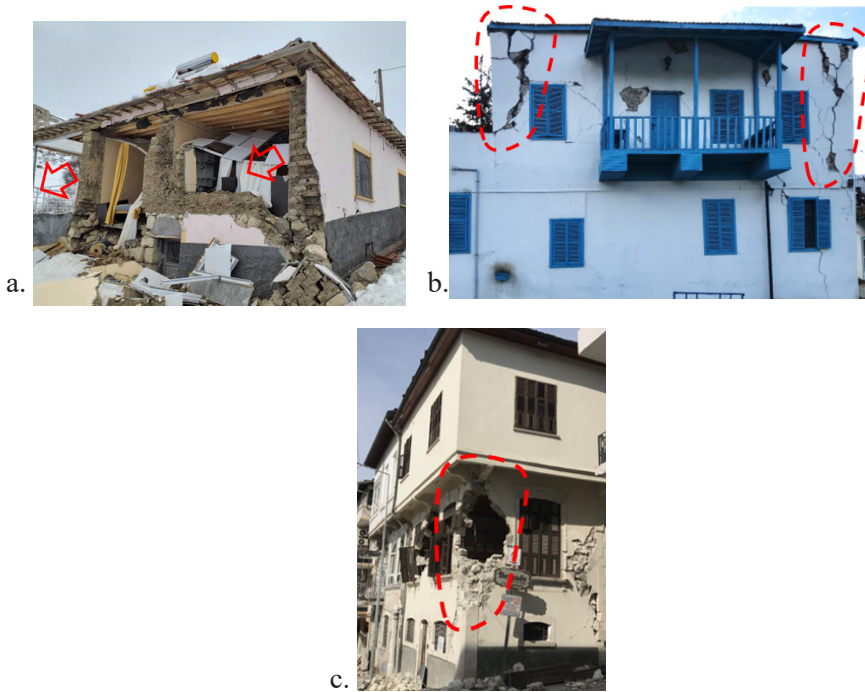
Figure 15. *a. Wall-to-wall connection failure b. Corner failure along with in-plane damages c. Partial collapse due to lack of corner connection and in-plane damages*

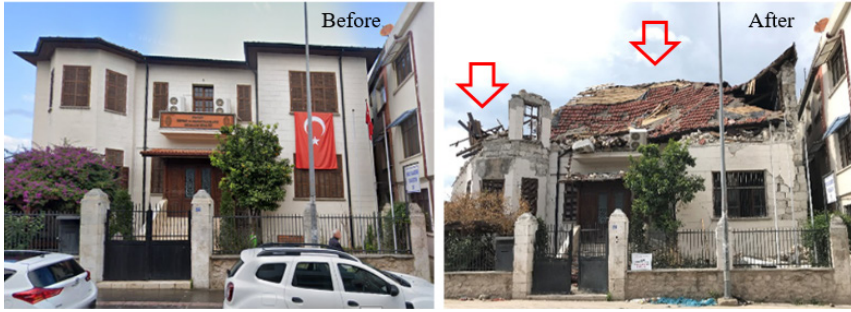
Fig. 17. Before earthquake (Google Street View, 2022) situation b. After the earthquake situation of the historic building of the Union of Chamber for Merchants and Craftsmen in Antakya, Hatay
